79th St and Cicero Ave

< Eastbound and Southbound>

RLR Crash Data and Analysis

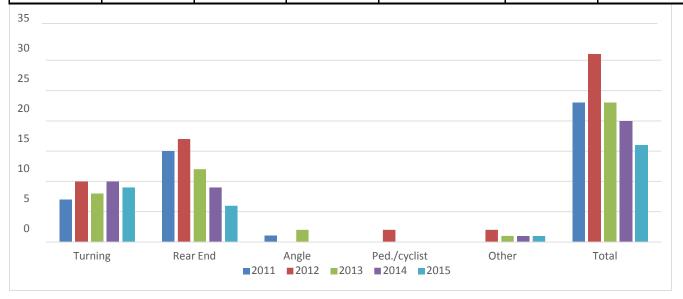
The table and chart below show a summary of motor vehicle crashes at the intersection of 79th St and Cicero Ave over a span of 5 years. The data from 2011 to 2013 show the period prior to the installation of RLR cameras. The data from 2014 show the year in which the cameras were installed. The data from 2015 show the year following the installation.

Turning	Rear End	Angle	Ped./cyclist	Other	Total
2011	7	15	1	0	0	23
2012	10	17	0	2	2	31
2013	8	12	2	0	1	23
2014	10	9	0	0	1	20
2015	9	6	0	0	1	16

At the intersection of 79th St and Cicero Ave there were 23 accidents in 2011, 31 in 2012, 23 in 2013, 20 in 2014 and 16 in 2015.

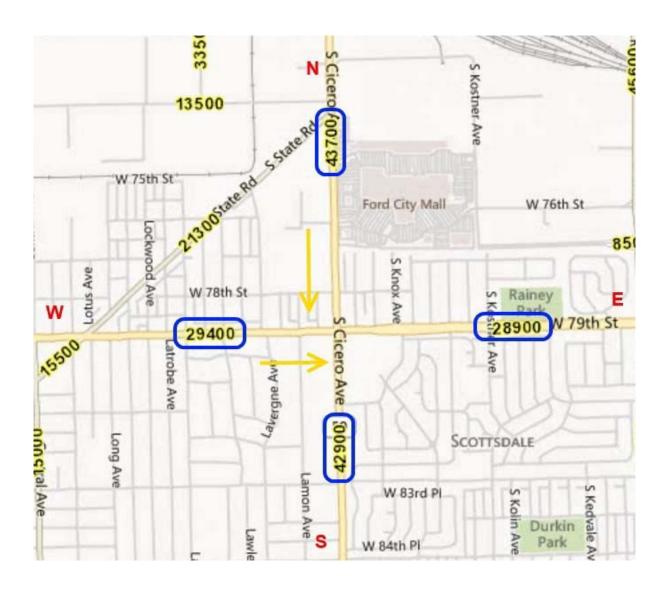
79th St ADT

East: 28,900West: 29,400

In 2013 the Average Daily Traffic (ADT) along 79th St reached 29,000 cars at the intersection of 79th St and Cicero Ave. During the same year the ADT along Cicero Ave reached 43,000 cars, according to IDOT.

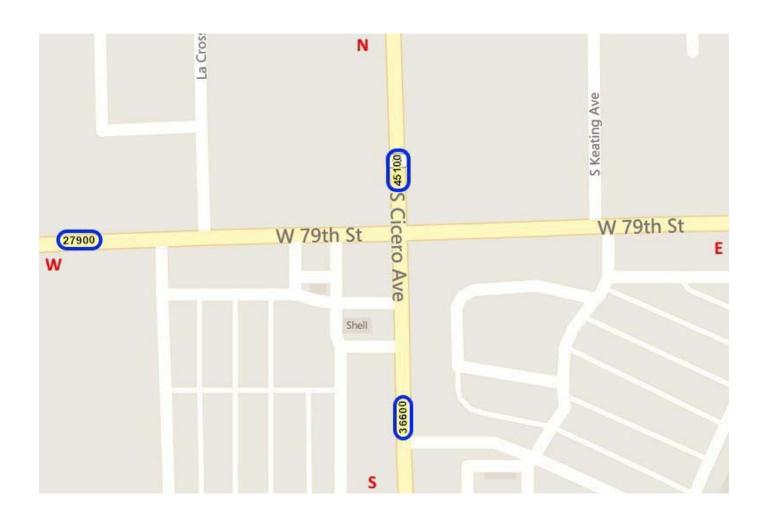
79th St ADT

The traffic numbers below were obtained from the IDOT website per the RLR Guideline document published by IDOT. Only ADT values were available, peak numbers were not provided.

East: 27,900West: 27,900

In 2015 there was a decrease in ADT along Cicero Ave south of 79th St (36,000) and an increase north of 79th St (45,000). Along 79th St there was a decrease in both directions (27,000).
